**RCRA FACILITY ASSESSMENT REPORT  
NALCO CHEMICAL COMPANY  
SUGARLAND, TEXAS  
(TXD008084618)**

**Prepared for**  
**U.S. Environmental Protection Agency**  
**Region 6**  
**1445 Ross Avenue**  
**Dallas, TX 75202**

**Prepared by**  
**PRC**  
**350 North St. Paul**  
**Suite 2600**  
**Dallas, TX 75201**

**February 1993**

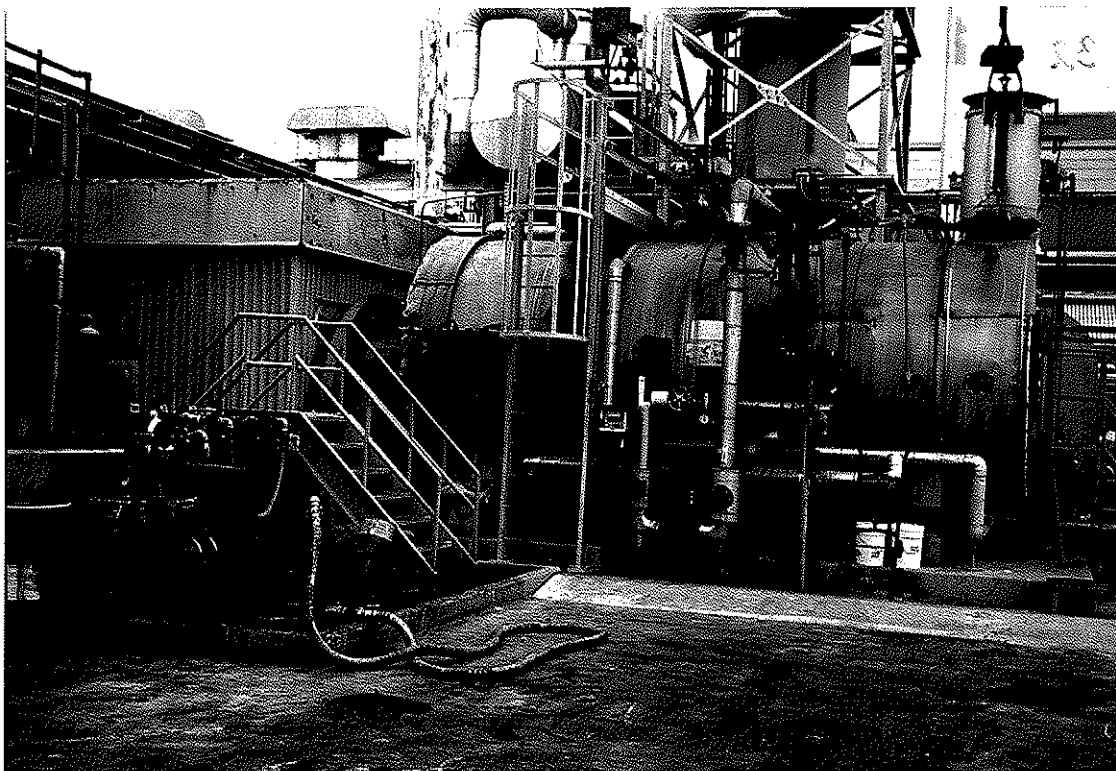
PHOTOGRAPH NO. 1

The incinerator (Photographs No. 1 and 3) operates as a heat recovery boiler. Heat generated by burning of the waste is used to generate steam for use throughout Nalco Sugarland. The heating capacity of the unit is 20,000,000 British thermal units (BTU) per hour (TWC, 1989). The incinerator includes a caustic scrubber for emission control. The stack discharge is about 50 feet above ground level. The incinerator is located on a 75-by-40-foot concrete slab surrounded by a 6-inch-high berm, which is centrally located at Nalco Sugarland.

Date: 11-23-92 Picture Taken By: Bill Clemons Direction Facing: East  
Description: Incinerator waste transfer area (SWMU No. 1) and incinerator (SWMU No. 3)

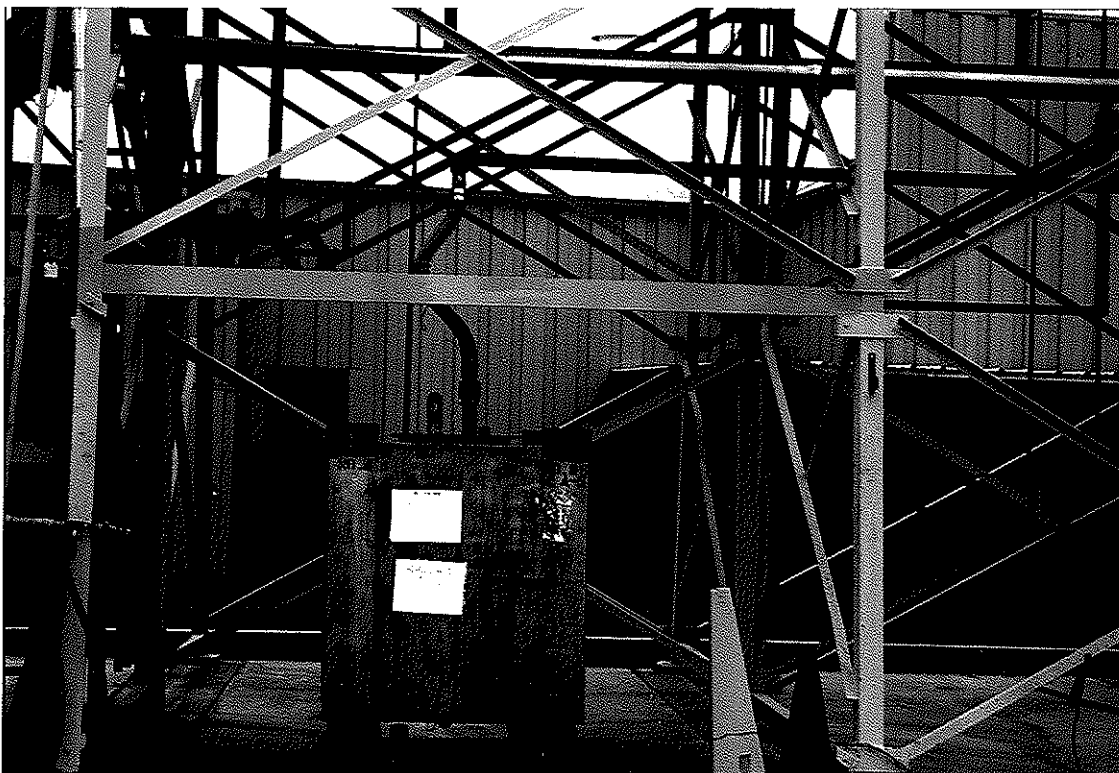
PHOTOGRAPH NO. 4

Date: 11-23-92 Picture Taken By: Bill Clemons Direction Facing: West  
Description: Tank 701 and 703 transfer area (SWMU No. 4)

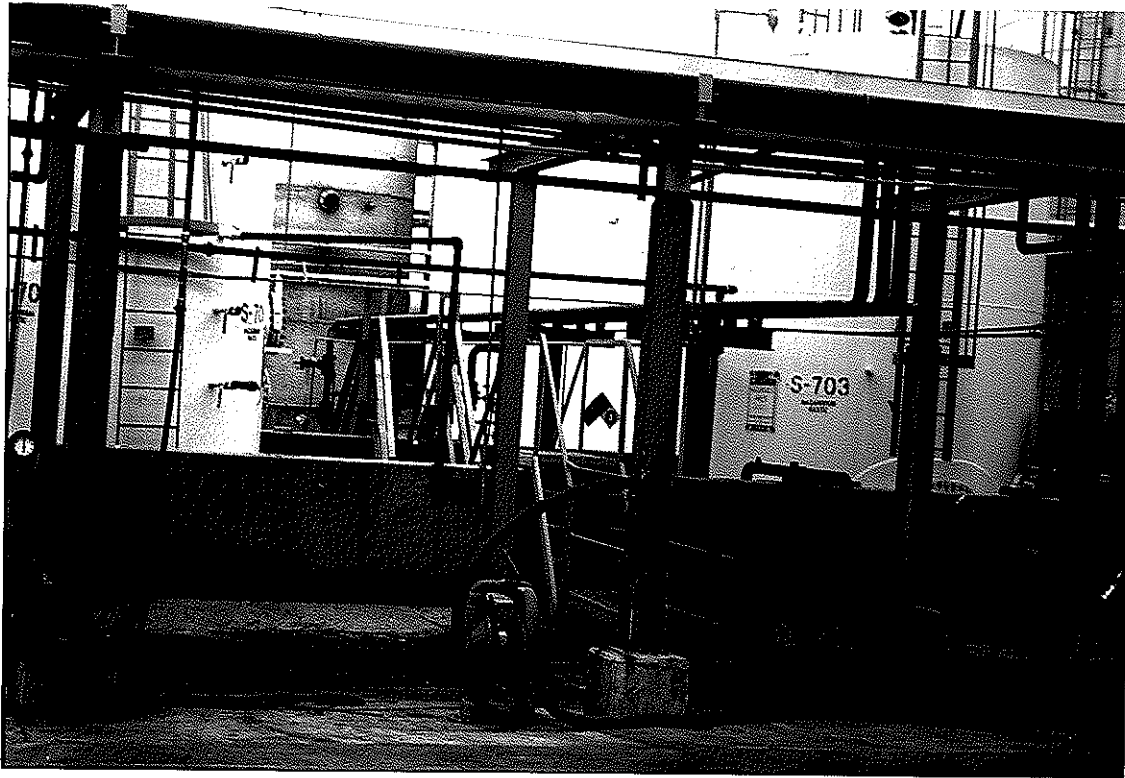
PHOTOGRAPH NO. 5

Date: 11-23-92 Picture Taken By: Bill Clemons Direction Facing: West  
Description: Tank 703 (SWMU No. 5) and Tank 701 (SWMU No. 6)

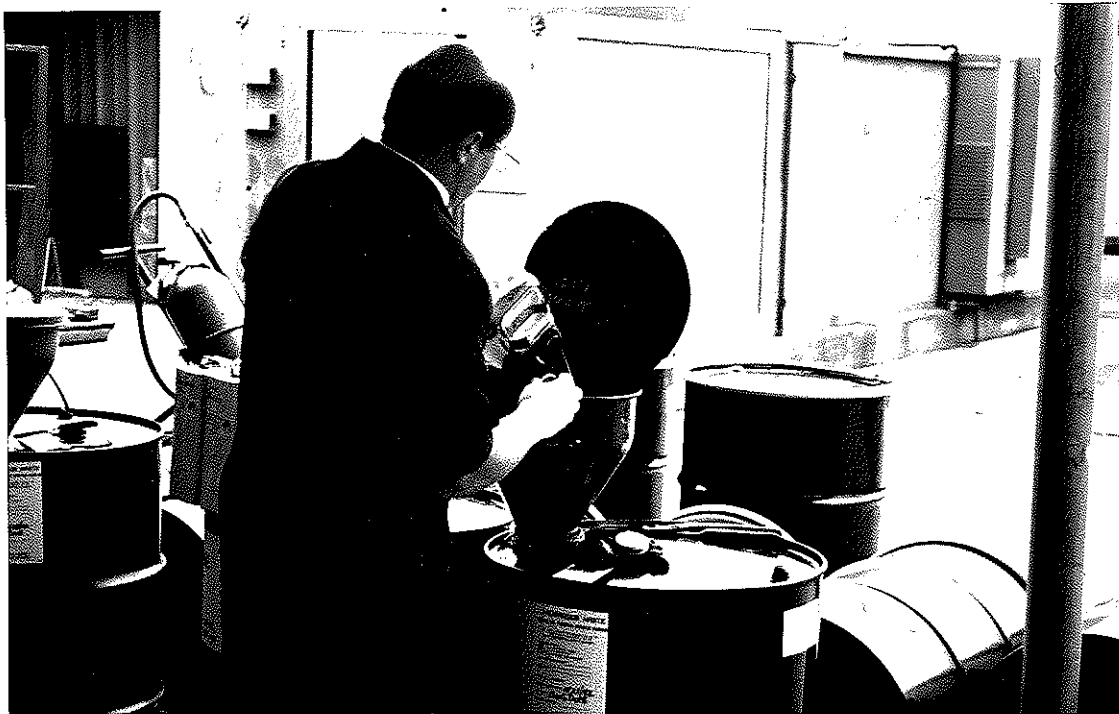
PHOTOGRAPH NO. 8

Date: 11-23-92 Picture Taken By: Bill Clemons Direction Facing: Southwest  
Description: Research container storage area (SWMU No. 8) and laboratory waste storage tank area (SWMU No. 9)

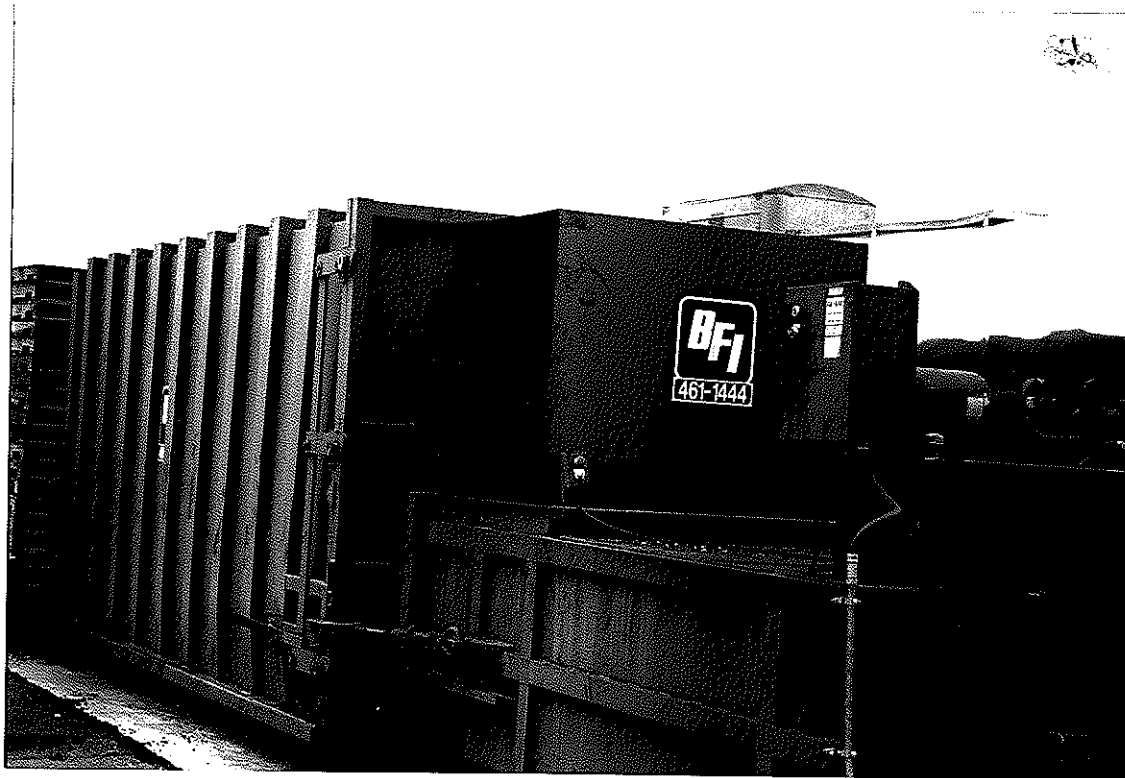
PHOTOGRAPH NO. 9

Date: 11-23-92 Picture Taken By: Bill Clemons Direction Facing: North-northeast  
Description: Research laboratory compactor (SWMU No. 10)

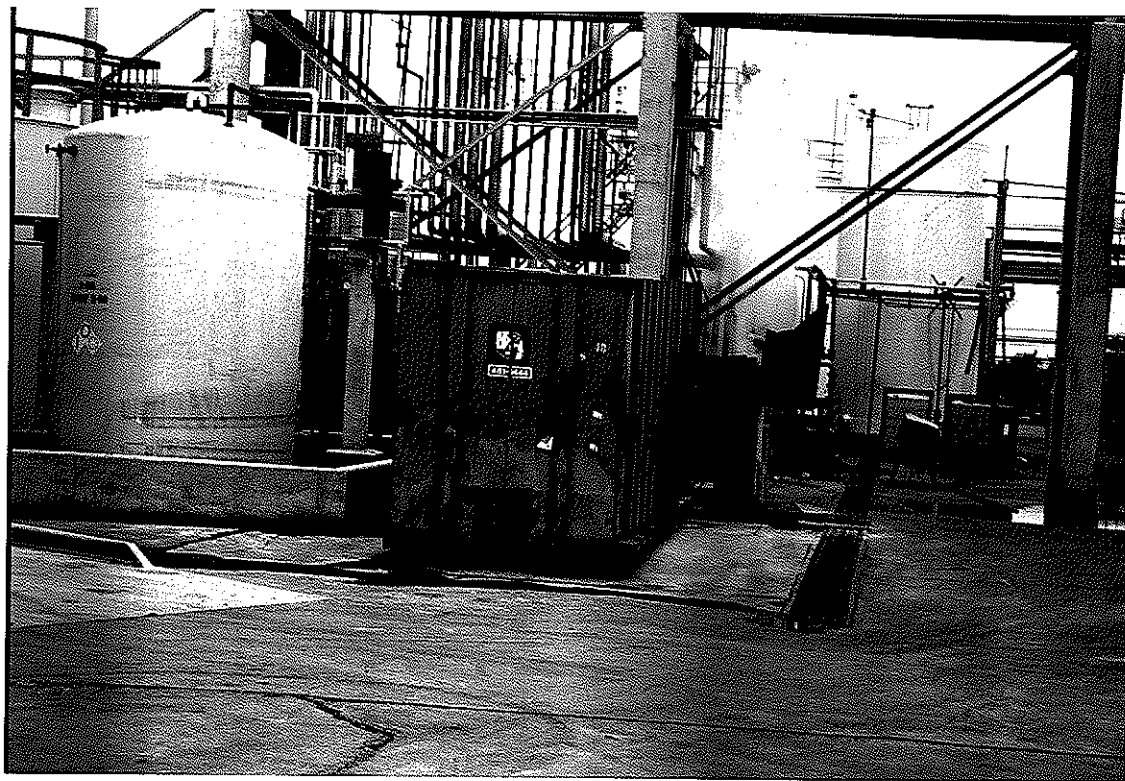
PHOTOGRAPH NO. 10

Date: 11-23-92 Picture Taken By: Bill Clemons Direction Facing: Southeast  
Description: Bulk storage compactor (SWMU No. 11)

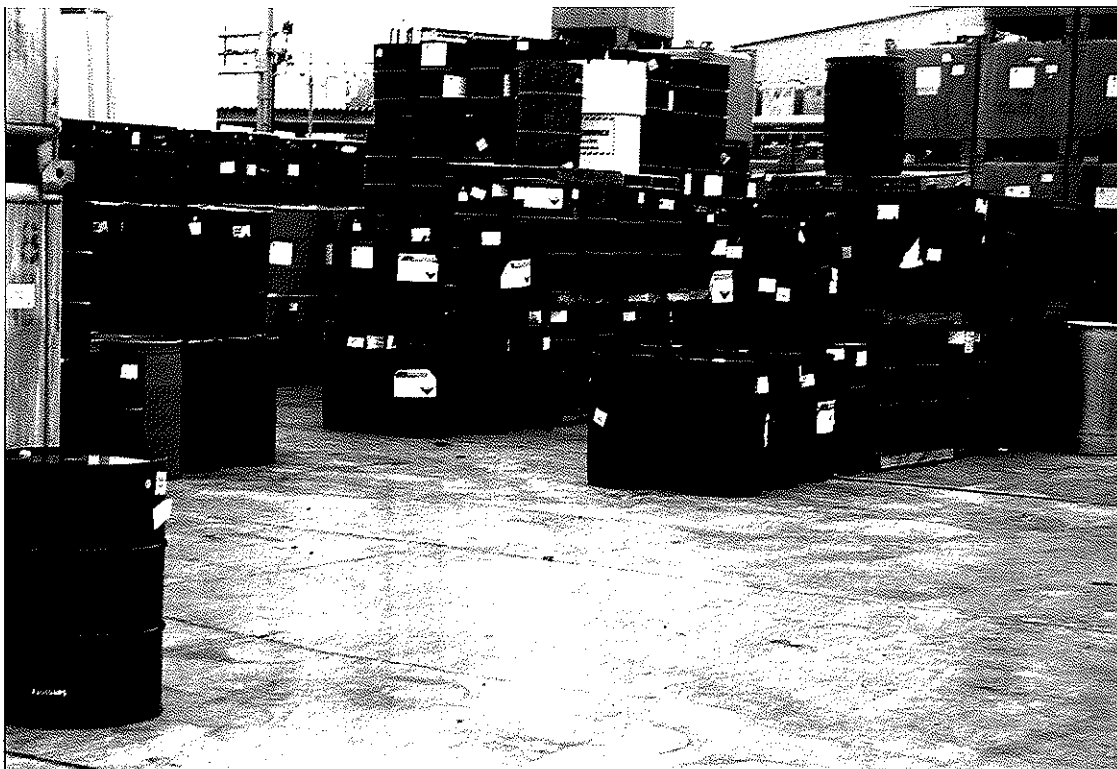
**PHOTOGRAPH NO. 11**

Date: 11-23-92 Picture Taken By: Bill Clemons Direction Facing: Southwest  
Description: Hazardous waste drum storage area (SWMU No. 12)

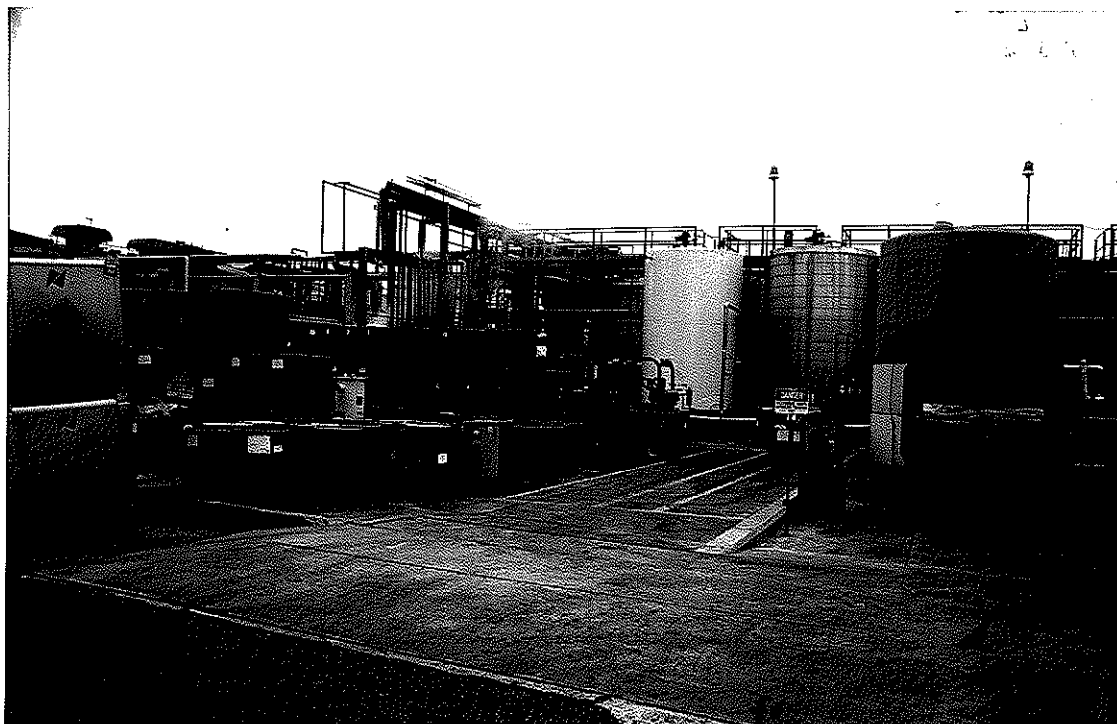
**PHOTOGRAPH NO. 12**

This SWMU is a trapezoidal concrete slab that measures about 5,600 square feet (Photograph No. 12). This area is located next to the hazardous waste storage area (SWMU No. 12). A 4-inch-high concrete berm surrounds the unit.

Date: 11-23-92 Picture Taken By: Bill Clemons Direction Facing: South-Southwest  
Description: Nonhazardous waste storage area (SWMU No. 13) and raw material bag compactor (SWMU No. 16)

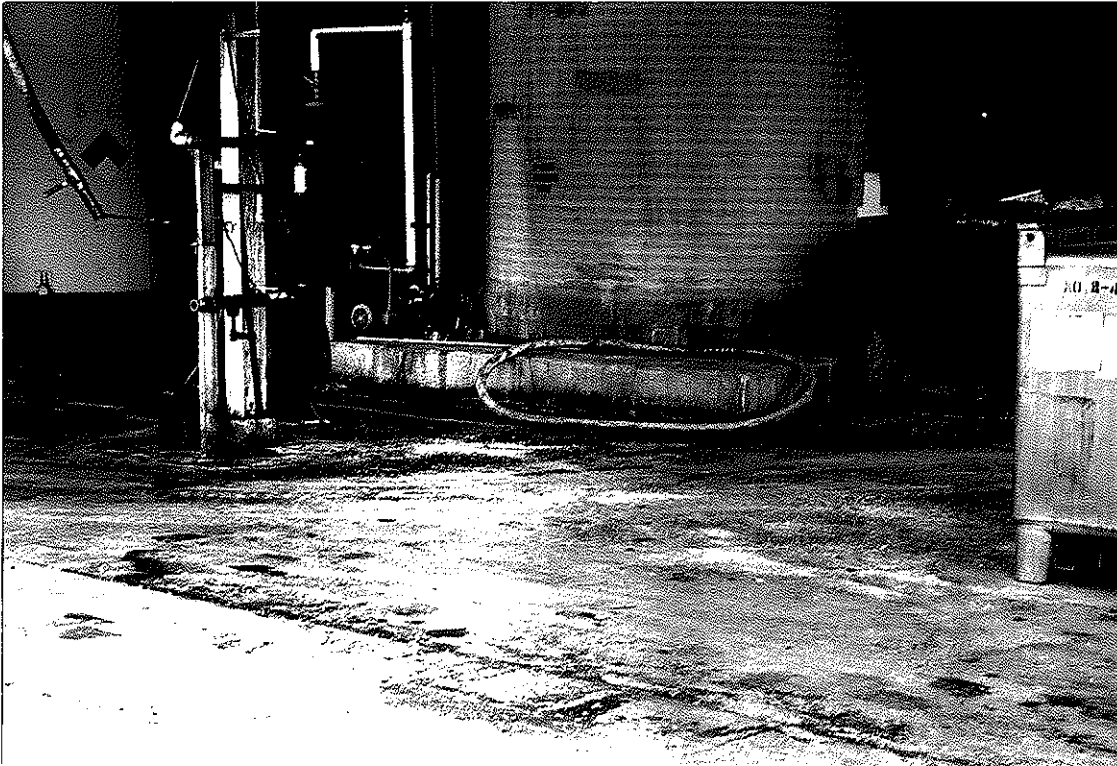
PHOTOGRAPH NO. 14

This SWMU was a 4,000-gallon aboveground tank. A sump was also associated with this unit. The sump collected rainwater, leaks, and spills, which were pumped into the chromate waste tank. The unit was in operation between January 1, 1985, and early 1987, when it was removed. The location of the former unit is now covered with a concrete slab (Photograph No. 14).

Date: 11-23-92 Picture Taken By: Bill Clemons Direction Facing: North  
Description: Chromate waste tank (SWMU No. 15) location

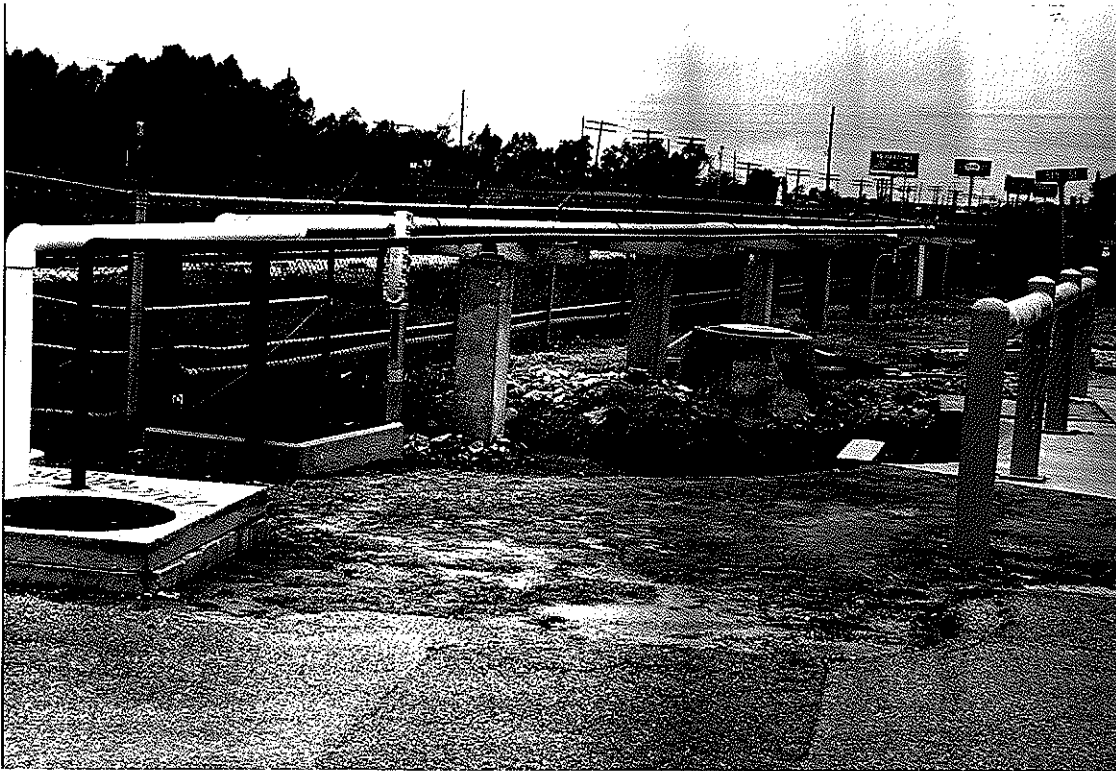
PHOTOGRAPH NO. 15

Date: 11-23-92 Picture Taken By: Bill Clemons Direction Facing: West-southwest  
Description: Former wastewater treatment sump (SWMU No. 17) location

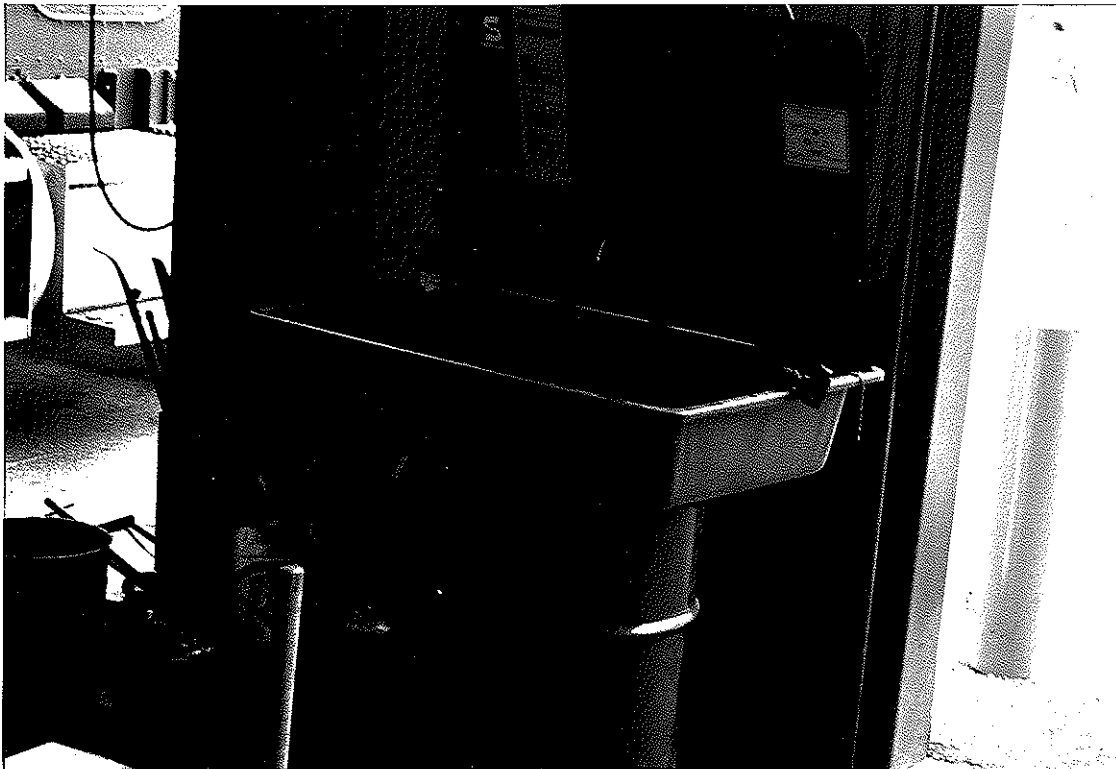
PHOTOGRAPH NO. 17

Date: 11-23-92 Picture Taken By: Bill Clemons Direction Facing: South-southeast  
Description: Parts-cleaner unit (SWMU No. 19)

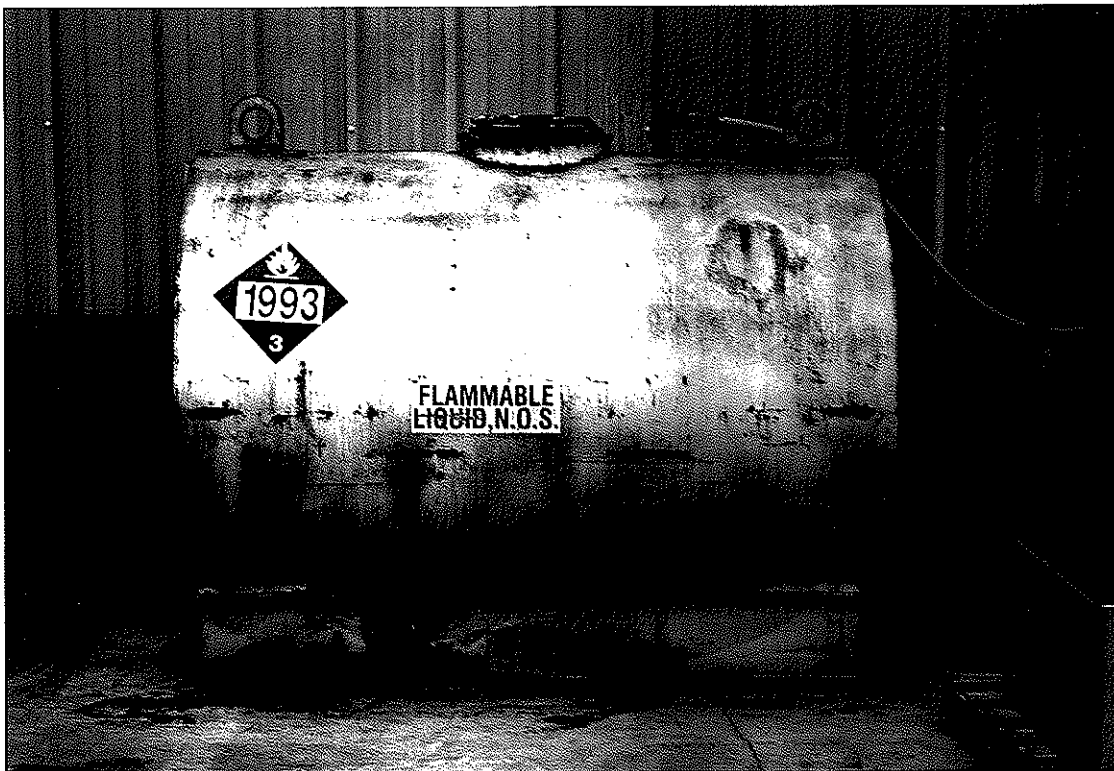
PHOTOGRAPH NO. 18

Date: 11-23-92 Picture Taken By: Bill Clemons Direction Facing: West  
Description: Waste oil tank (SWMU No. 20)

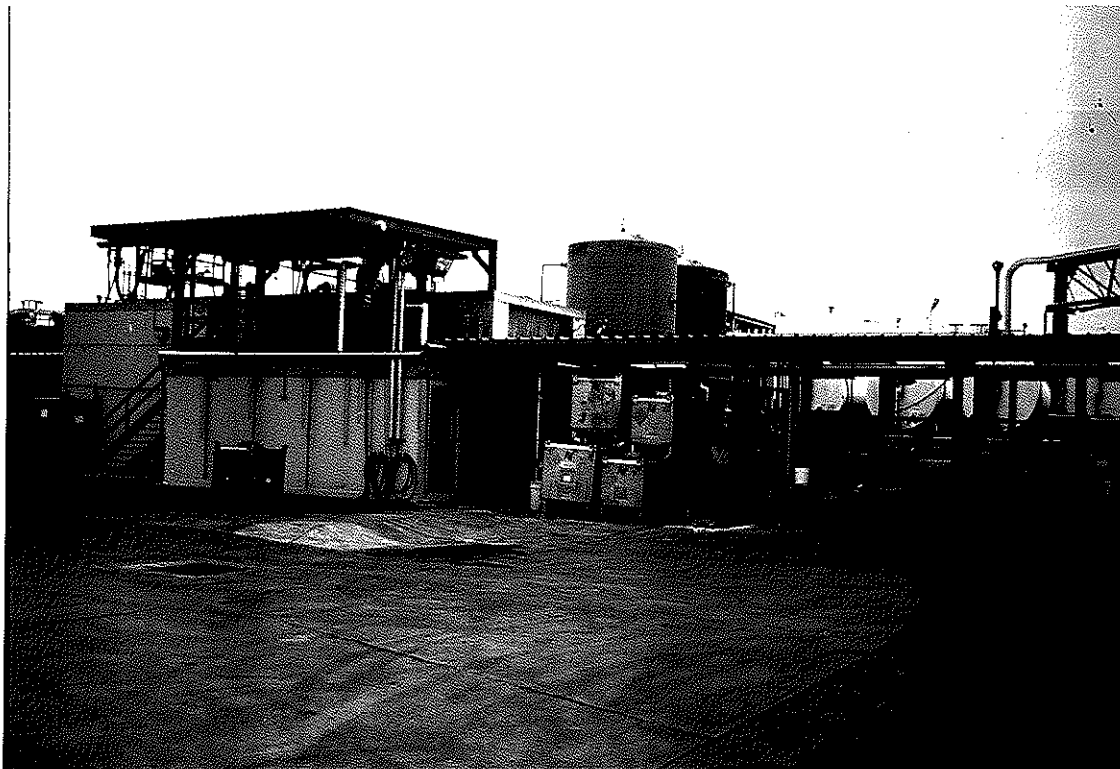
PHOTOGRAPH NO. 19

Date: 11-23-92 Picture Taken By: Bill Clemons Direction Facing: Northeast  
Description: Tote tank cleaning tanks (SWMU No. 21)

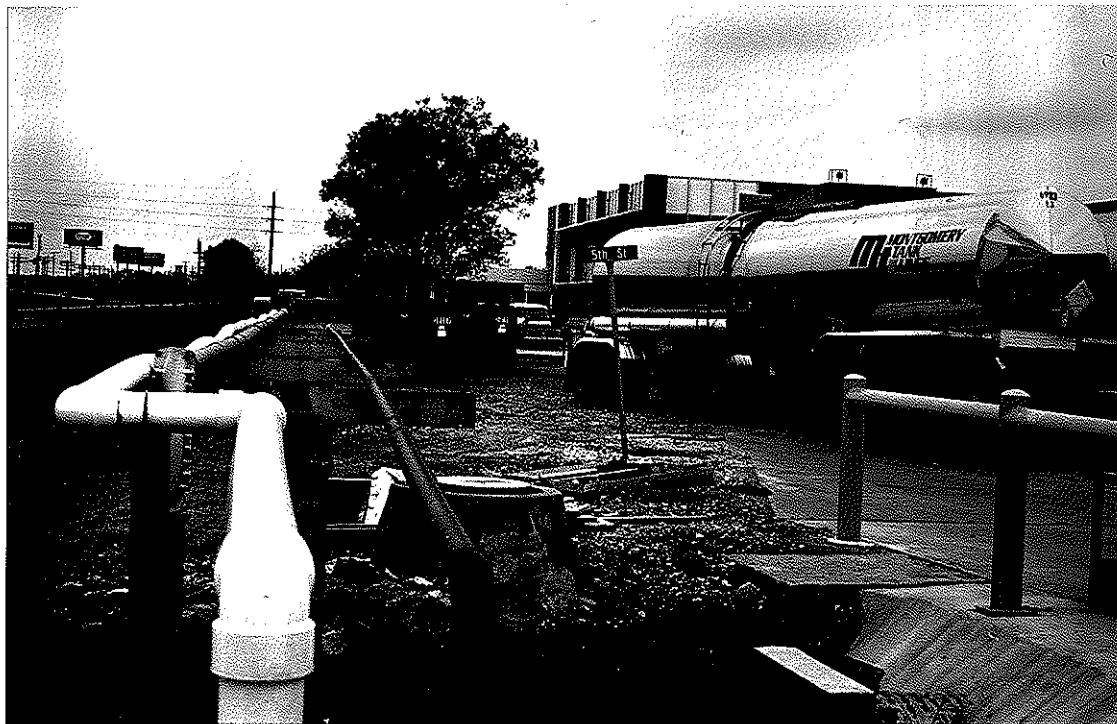
PHOTOGRAPH NO. 20

Date: 11-23-92 Picture Taken By: Bill Clemons Direction Facing: West  
Description: Former wastewater treatment system (SWMU No. 22) location and probable location of the waste pile (SWMU No. 25).

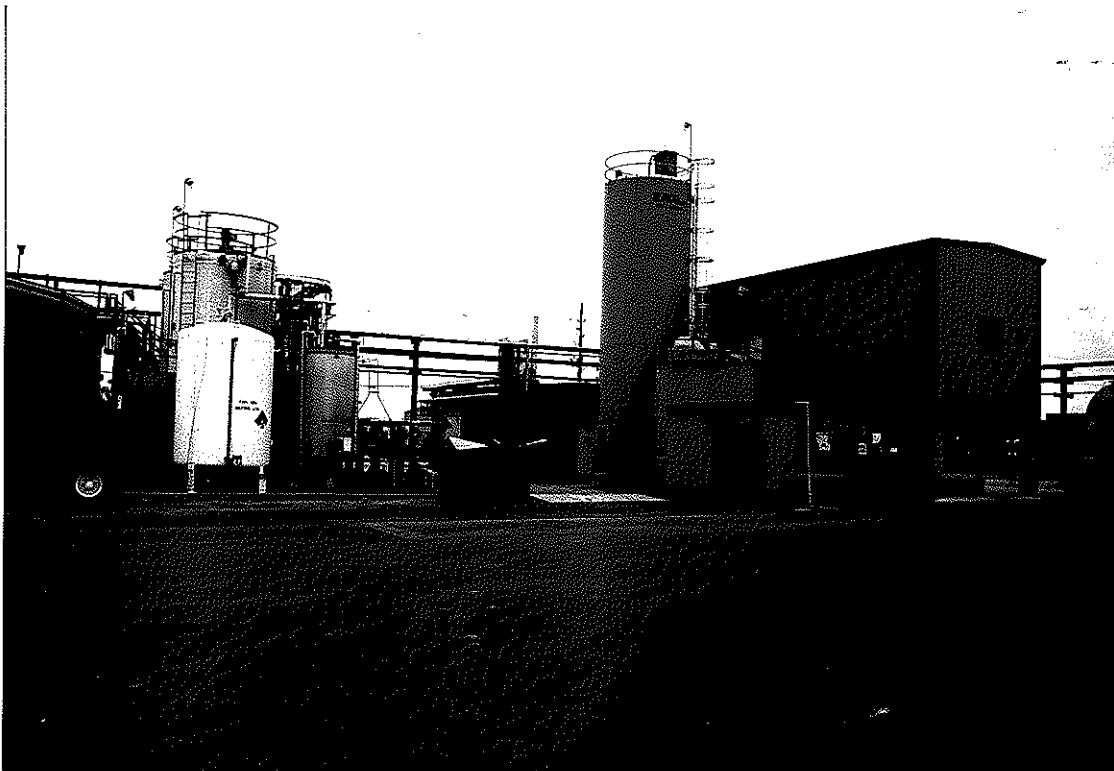
PHOTOGRAPH NO. 21

Date: 11-23-92 Picture Taken By: Bill Clemons Direction Facing: Northeast  
Description: New wastewater treatment system (SWMU No. 23)

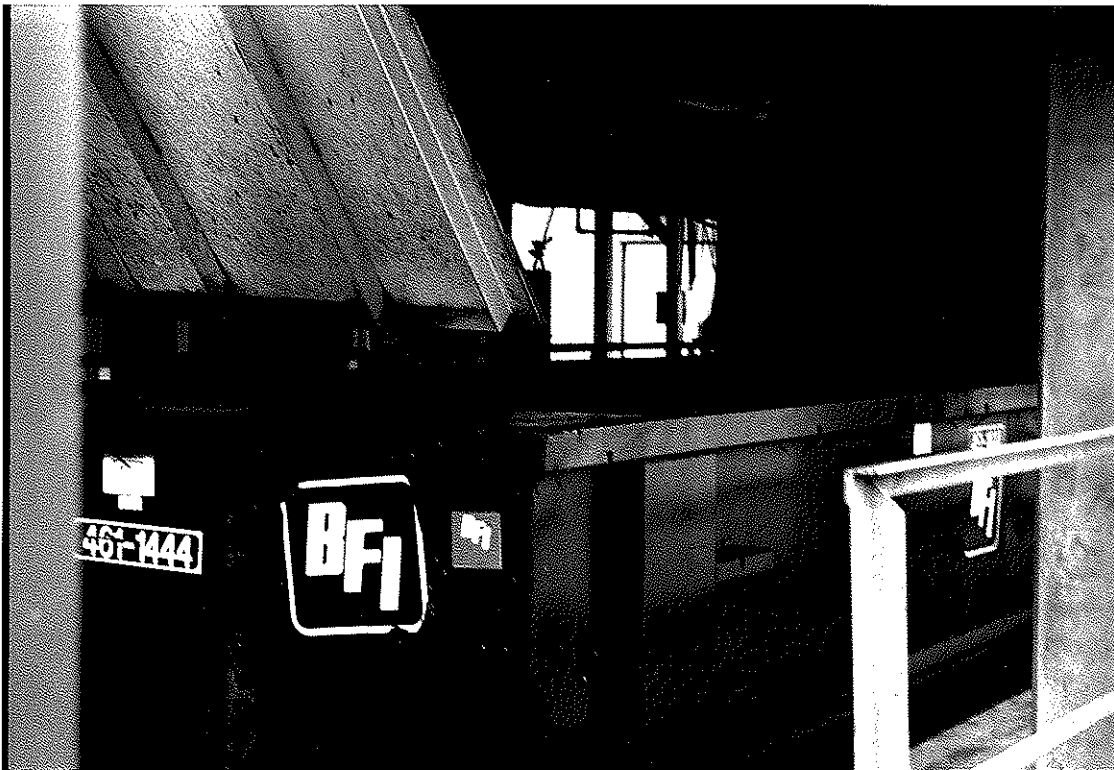
PHOTOGRAPH NO. 22

Date: 11-23-92 Picture Taken By: Bill Clemons Direction Facing: Northwest  
Description: Sludge bin storage area (SWMU No. 23)

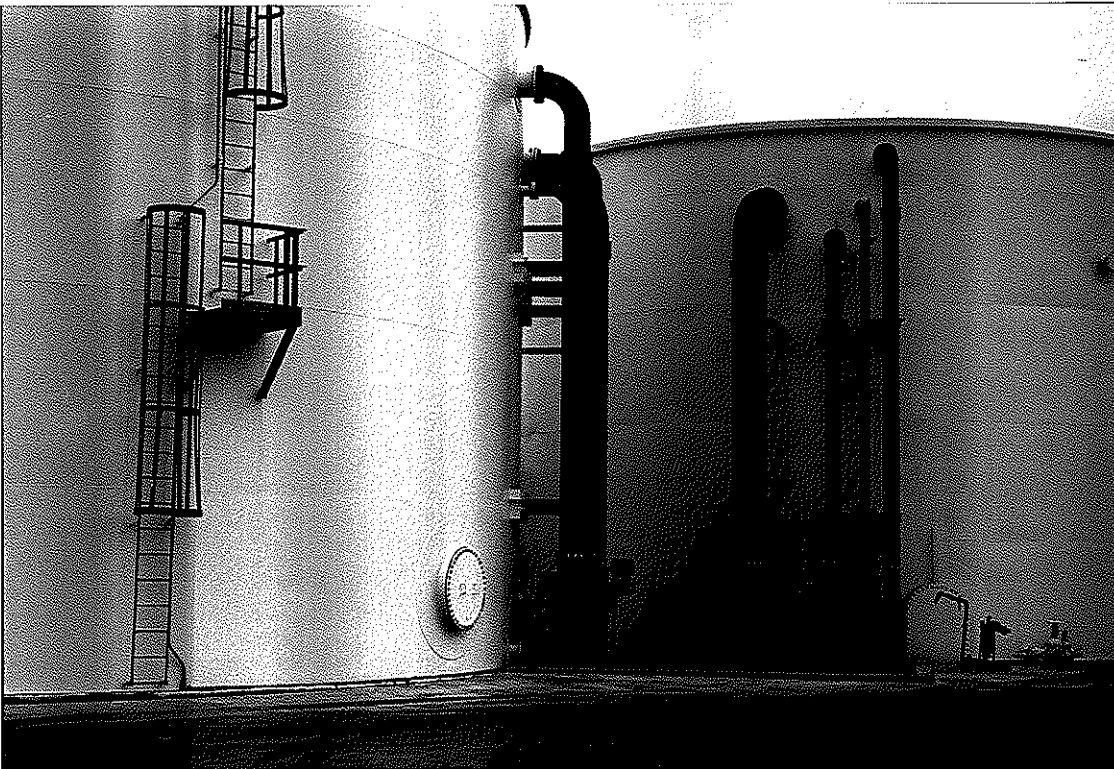
PHOTOGRAPH NO. 24

Date: 11-23-92 Picture Taken By: Bill Clemons Direction Facing: North-northeast  
Description: Tank S-131 shown on the left and Tank 702 shown on the right

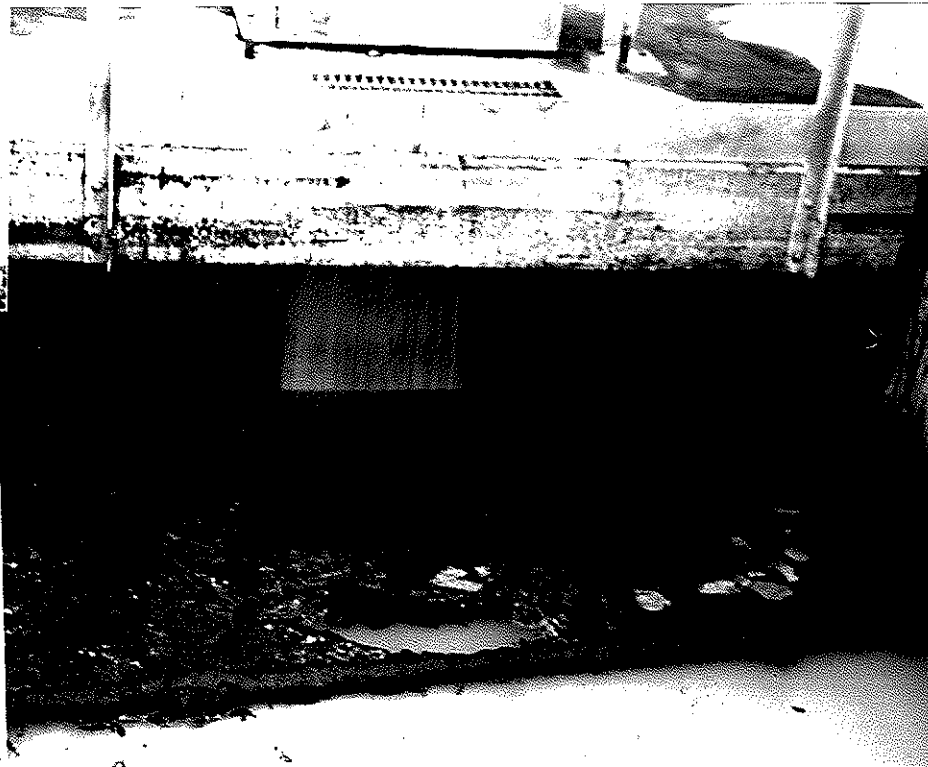
PHOTOGRAPH NO. 25

This SWMU is a subsurface double-walled steel-reinforced concrete basin with leak detection and a capacity of about 157,000 gallons (Photographs No. 16 and 25). It also includes an oil-skimming belt, which removes free-floating oils and grease.

Date: 11-23-92 Picture Taken By: Bill Clemons Direction Facing: Northwest  
Description: Oil-skimming belt component of the storm water basin (SWMU No. 24)

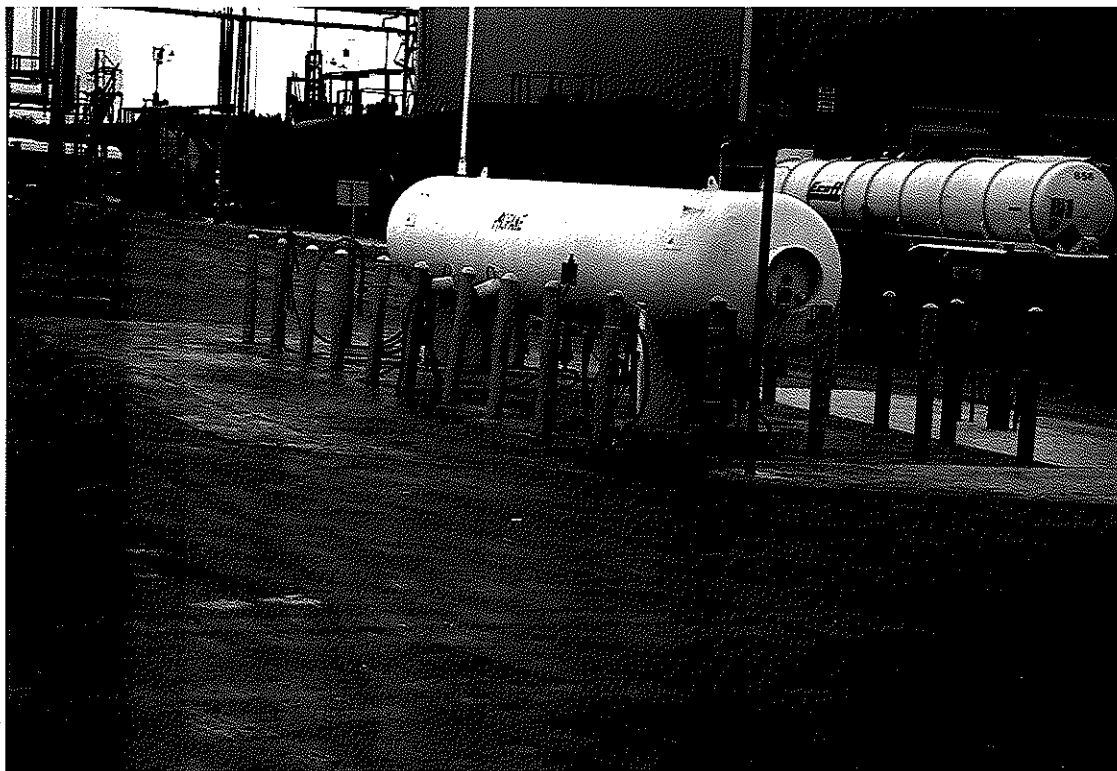
PHOTOGRAPH NO. 26

According to the Nalco representatives, a burnpit may have been present at Nalco Sugarland, south of the new wastewater treatment system (Photograph No. 26). No information was available regarding the size of this unit.

Date: 11-23-92 Picture Taken By: Bill Clemons Direction Facing: Northwest  
Description: Former burn pit location (SWMU No. 26)

PRC recommends an RFI.

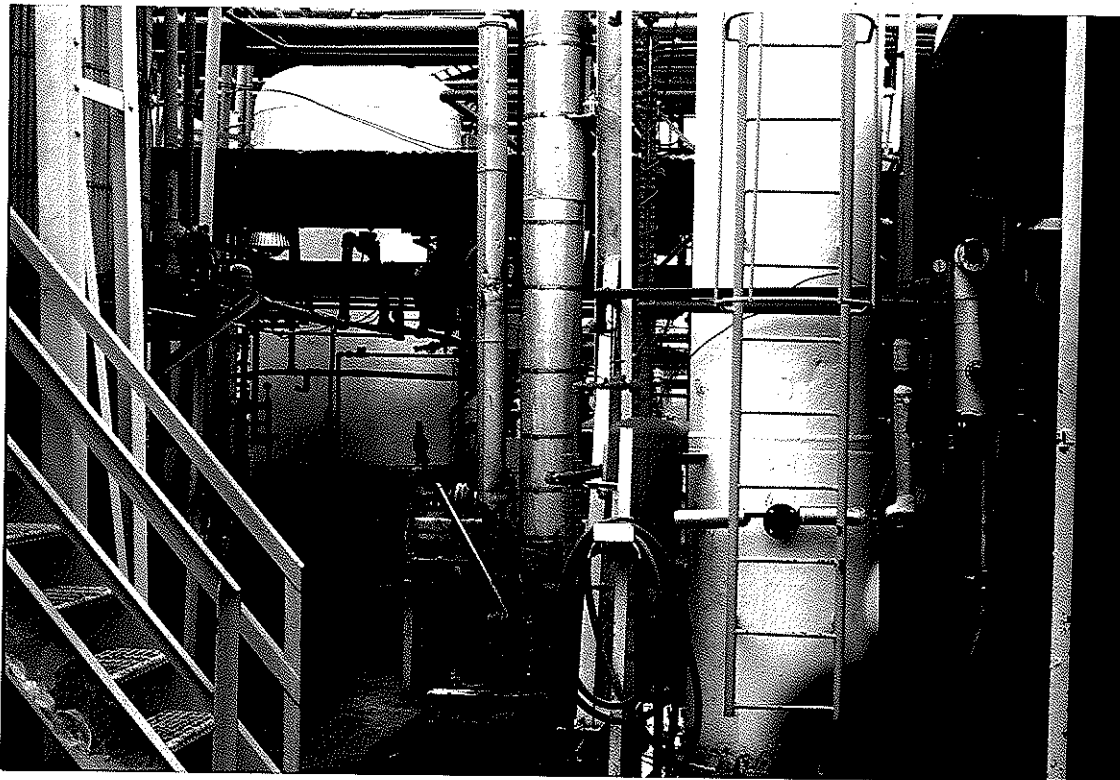
PHOTOGRAPH NO. 27

The oxyalkylation area (Photograph No. 27) is a process area of Nalco Sugarland that was active from 1953 to mid-1990. According to Nalco representatives, soil borings and ground-water samples collected in this area were found to be contaminated with organic constituents. No additional information regarding the constituents and levels of contamination were available in any files reviewed. Nalco representatives indicated that information regarding this area has been sent to TWC

Date: 11-24-92 Picture Taken By: Bill Clemons Direction Facing: West  
Description: Oxyalkylation area (AOC No. 1)

during the past year. PRC recommends an RFI for this unit because there is suspected soil and ground-water contamination in this area.

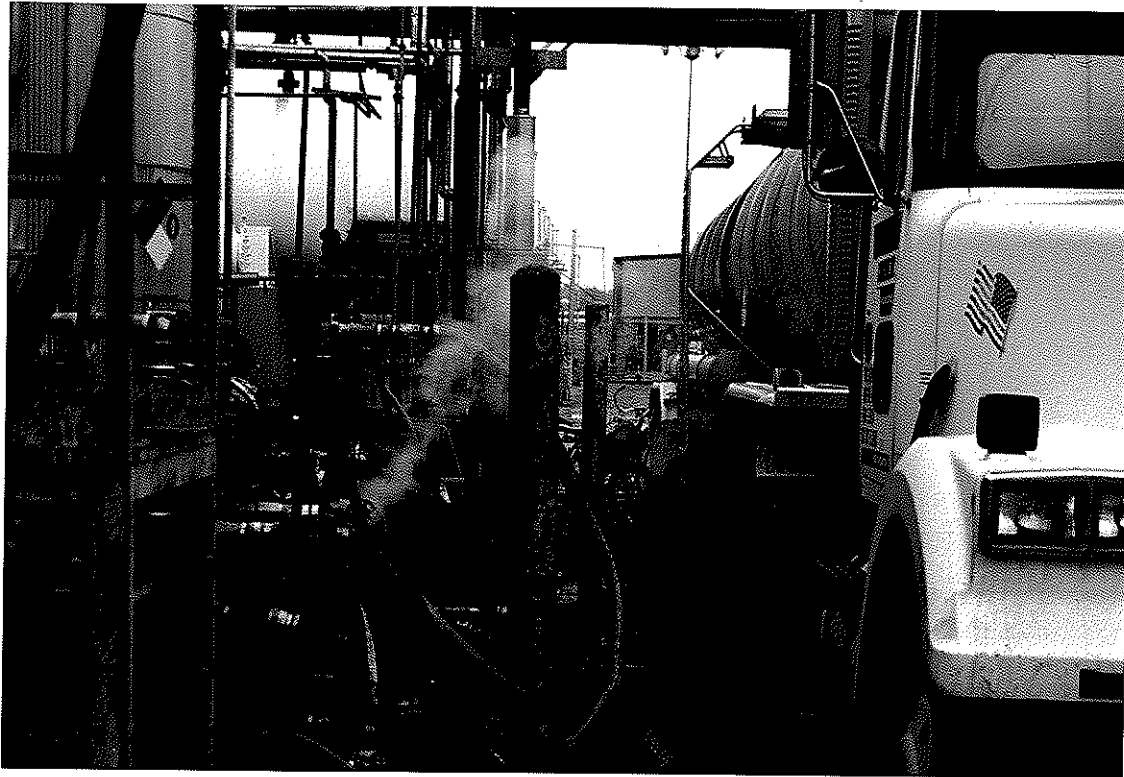
The 16 upright unloading area (Photograph No. 29) is located about 80 feet southwest of the hazardous waste drum storage area (SWMU No. 12) and immediately west of the 16 upright tank area. According to Nalco representatives, about 40 cubic yards of soil that were contaminated with organics were removed from this area in 1987. PRC recommends an RFI for this unit because soil contamination is suspected in this area.

Date: 11-24-92 Picture Taken By: Bill Clemons Direction Facing: South  
Description: 16 upright unloading area (AOC No. 3)
